# Petun Dam Removal Project

Fred Dobbs, Manager Stewardship Services  
Laura Wensink, River Restoration Technician  
29 November, 2023

# Petun Dam Removal and Restoration of Black Ash Creek

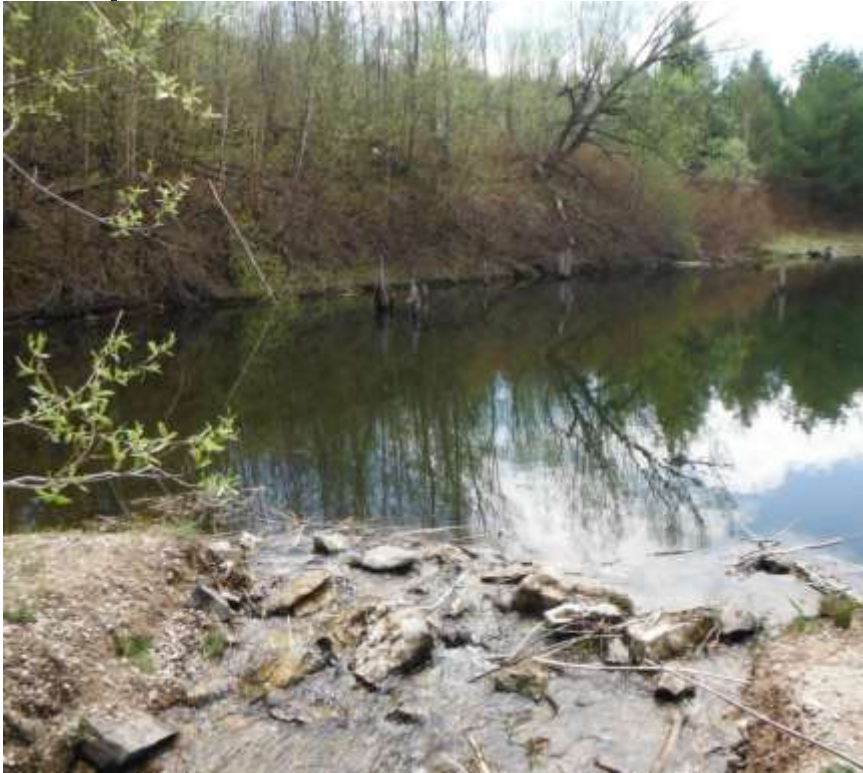
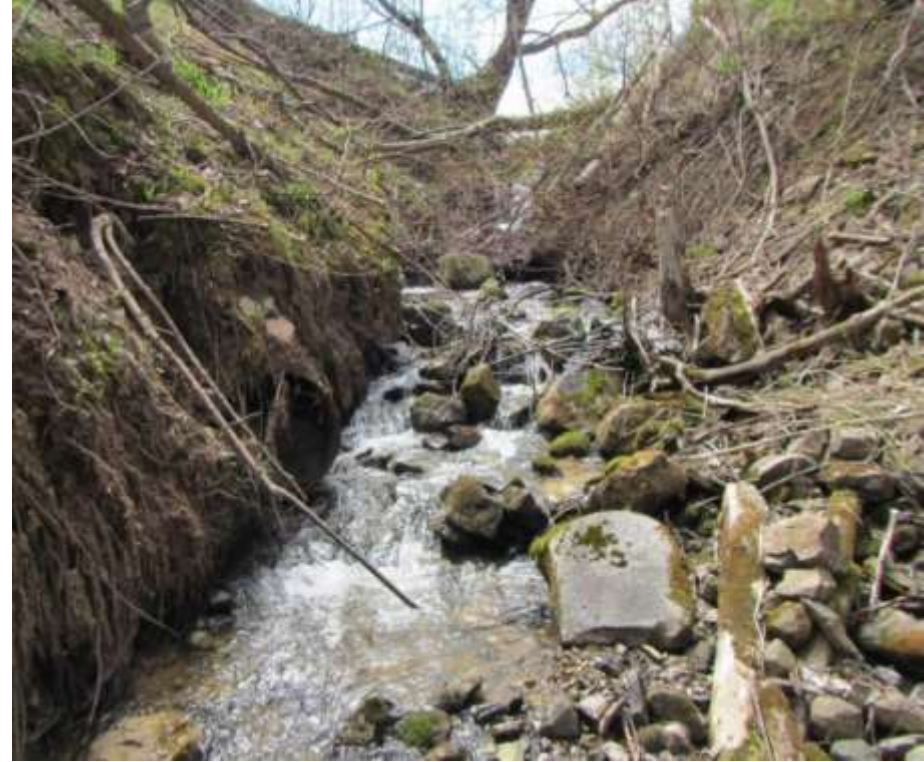
# Partially Failed Dam

- » The original water outlet pipe failed prior to 1992 and a new outlet channel eroded into the earthen dam.

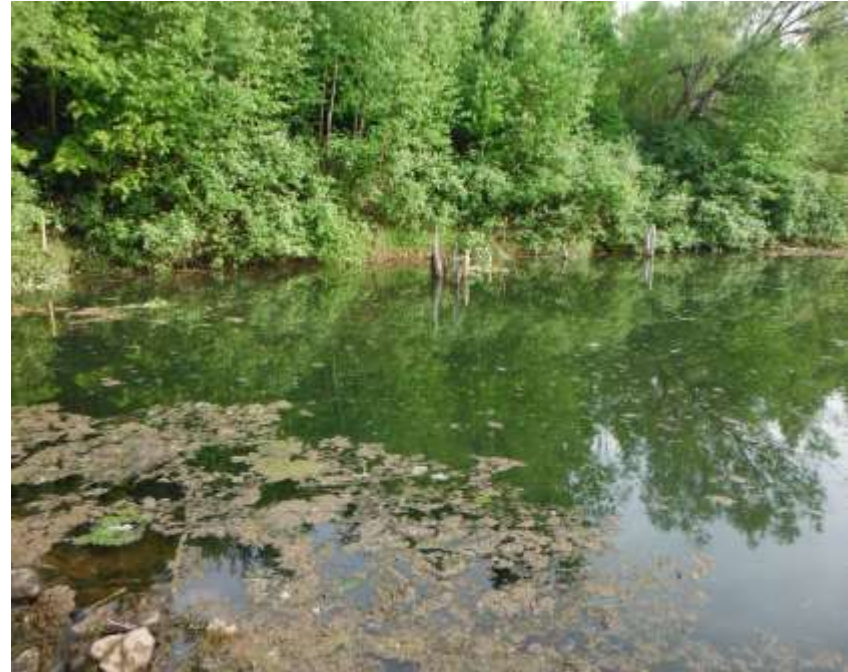
- » The remaining dam structure maintained a 100m long X 3m deep stagnant head pond.
- » The pond acted as a sink for sediment and attached nutrients which supported algae blooms.
- » Warming in stagnant head pond increased peak daily summer temperatures in Black Ash Creek by 7C, creating a decrease in habitat suitability for trout

Algal bloom in early June 2014
