# Dam Removal in Ontario: Successes and Challenges

Instream Barrier Removal Workshop – November 29, 2023  
Tiffin Center for Conversation – NVCA – Utopia, Ontario  
Sponsored by the American Fisheries Society Ontario Chapter

Presented by Jeff Graham, P. Eng. President  
GSS Engineering Consultants Ltd.  
Owen Sound, Ontario

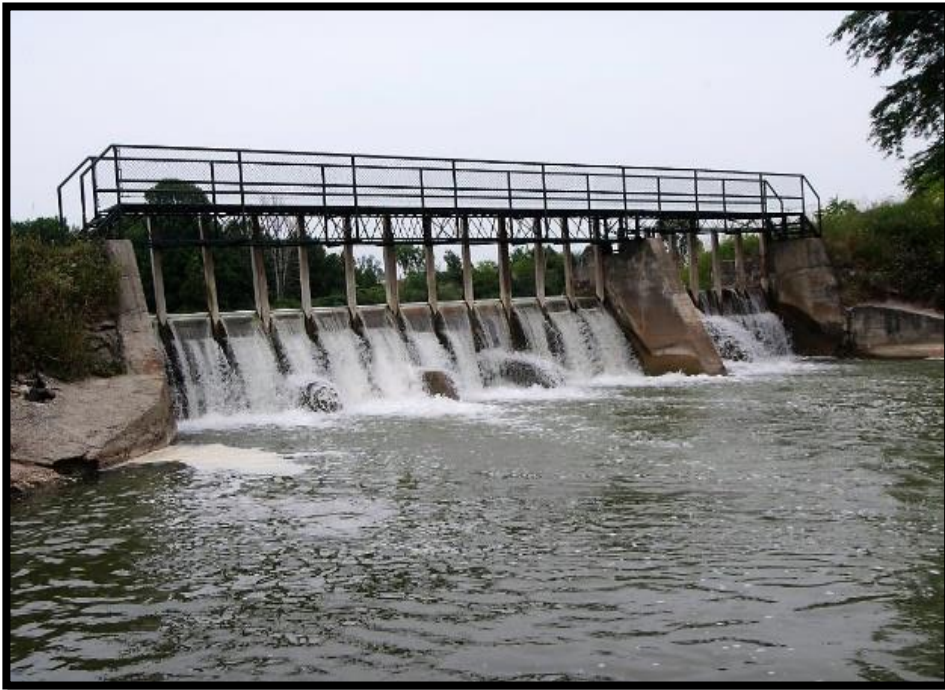
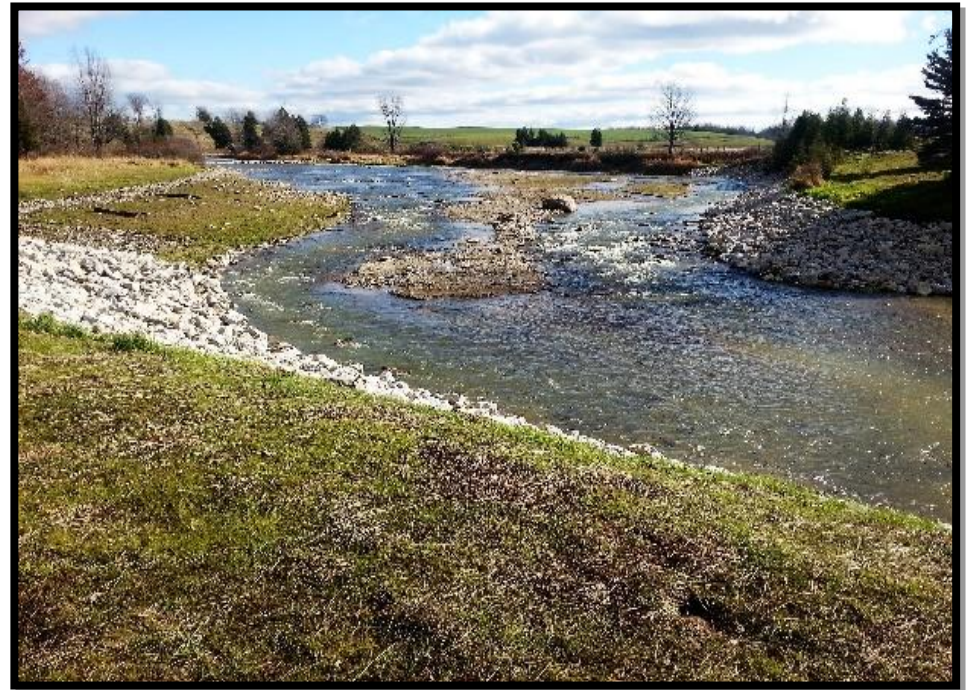
# Lockerby Dam Removal – North Saugeen River near Paisley (2015)

- Minimum sediment at this location
- Site access on far side of dam a challenge – required private property access arrangements

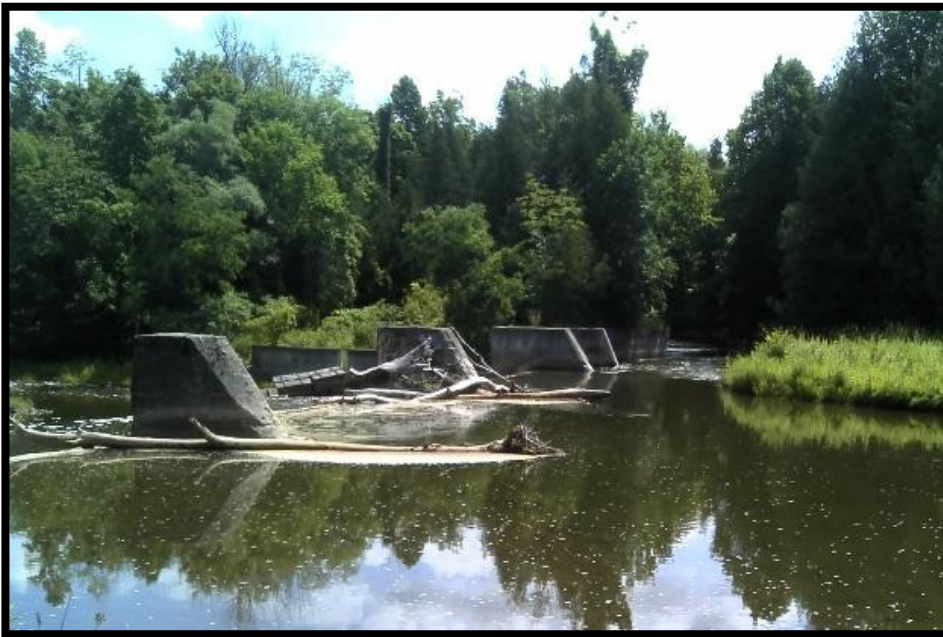
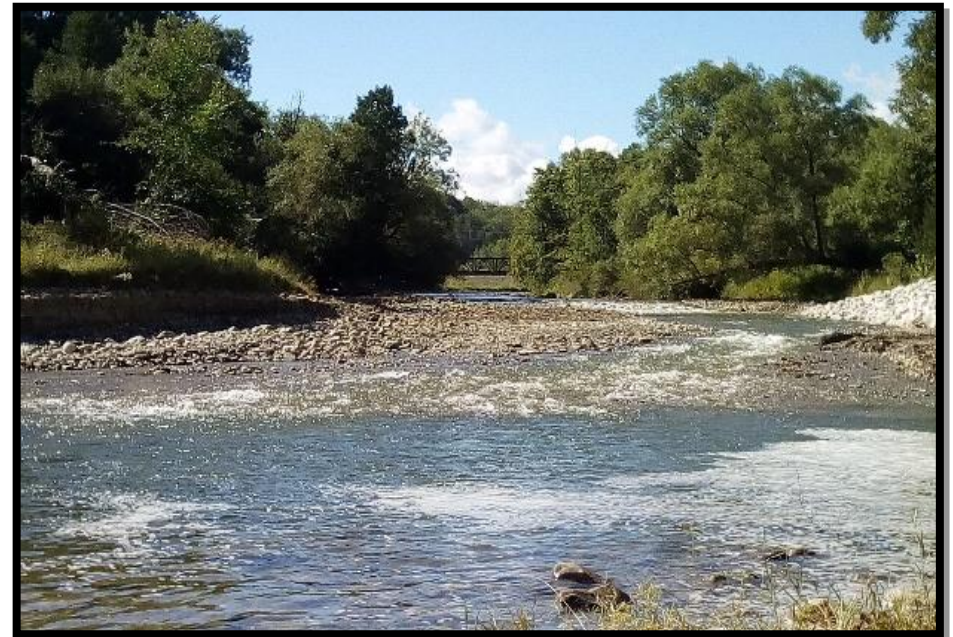
# Haines Dam Removal – Beaver River in Clarksburg (2016)

- Significant volume of coarse, cobble sediment stored in head pond. Some removed
- Very significant volume of large rip rap placed along west side to protect river front homes
- Remnants of dam on east side of the river left in place as no easy access on east side.

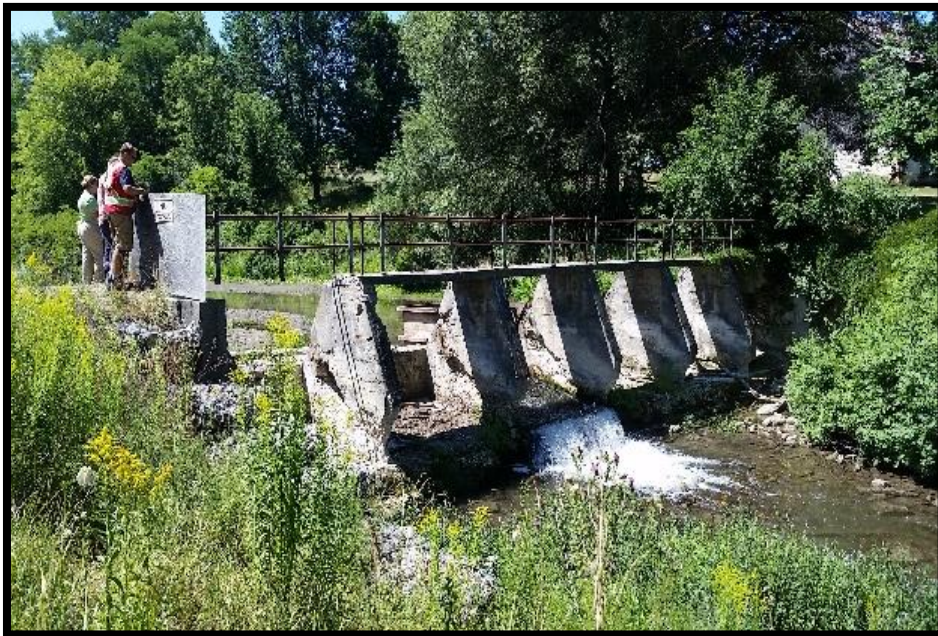
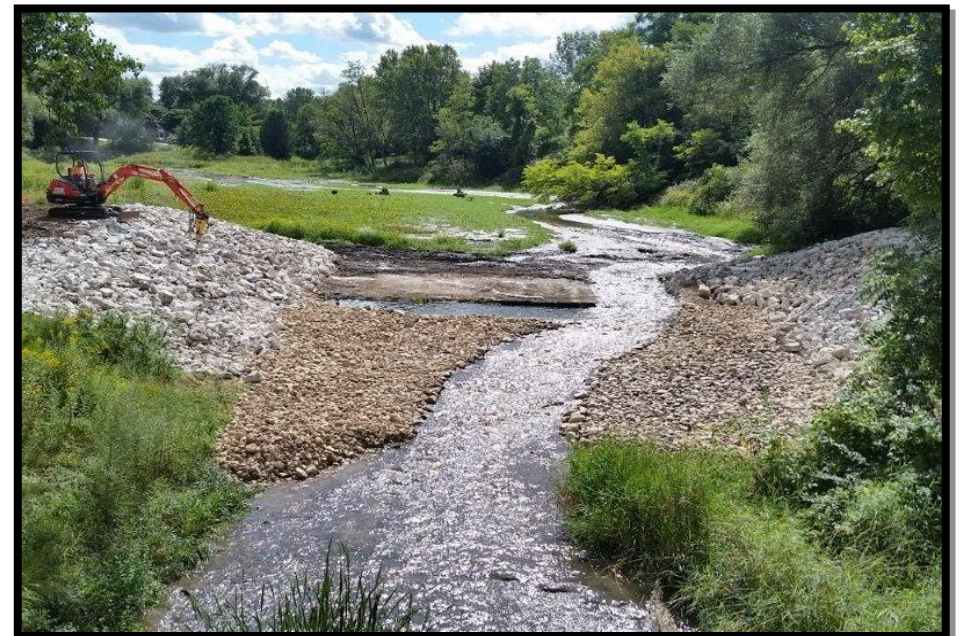
## Hamel Dam Removal – Otter Creek in Mildmay (2016)

- Minimal head pond sediment as head pond largely drained previously
- Portion of former head pond filled with pit run gravel/topsoil/seeded etc. for new park land
- Remnant of dam base left in place to control upstream head cutting of remaining sediment

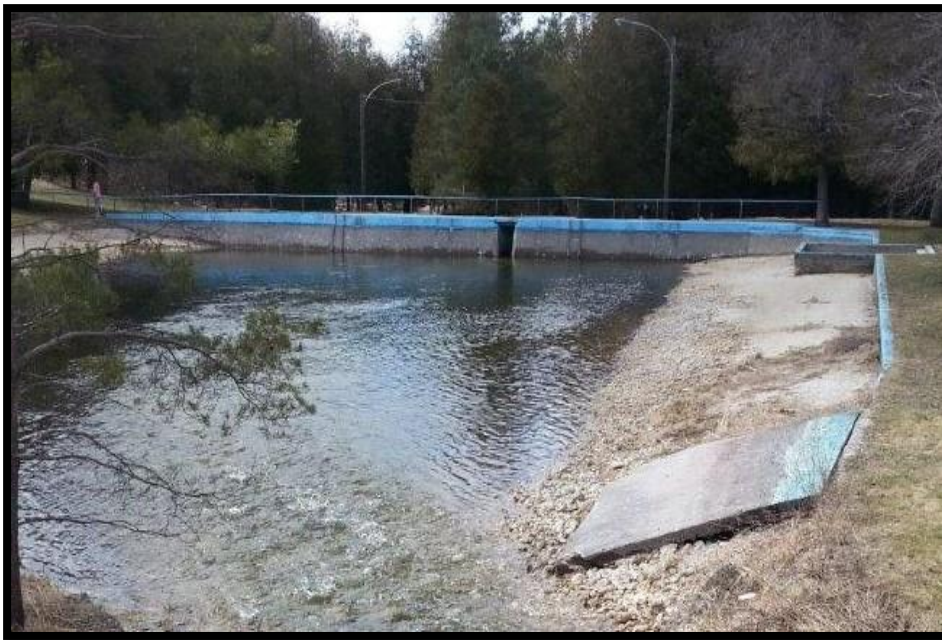
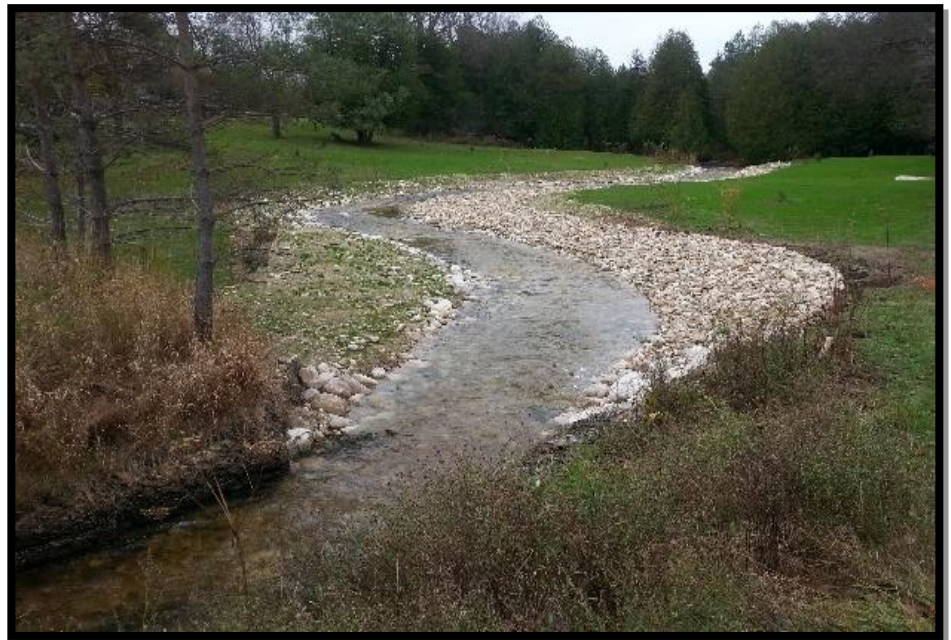
## Rotary Park Dam Removal – Armstrong Creek in Markdale (2017)

- High-quality, cold-water stream with native brook trout.
- Project to remove former on line swimming pond led by local Rotary Club
- Fortunately, existing bypass pipe was in place which allowed dam removal, and construction of new stream channel, to be done “in the dry”

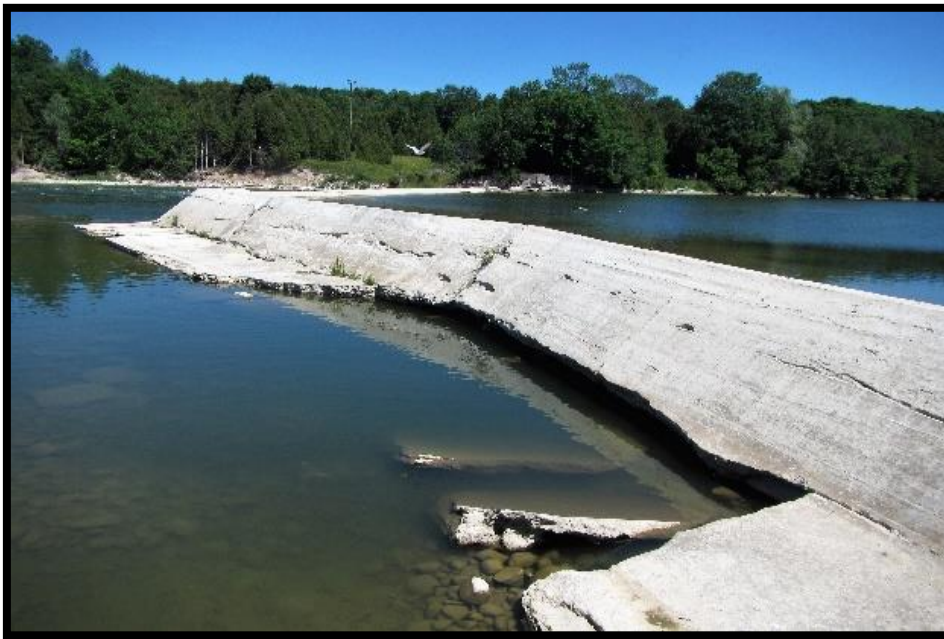
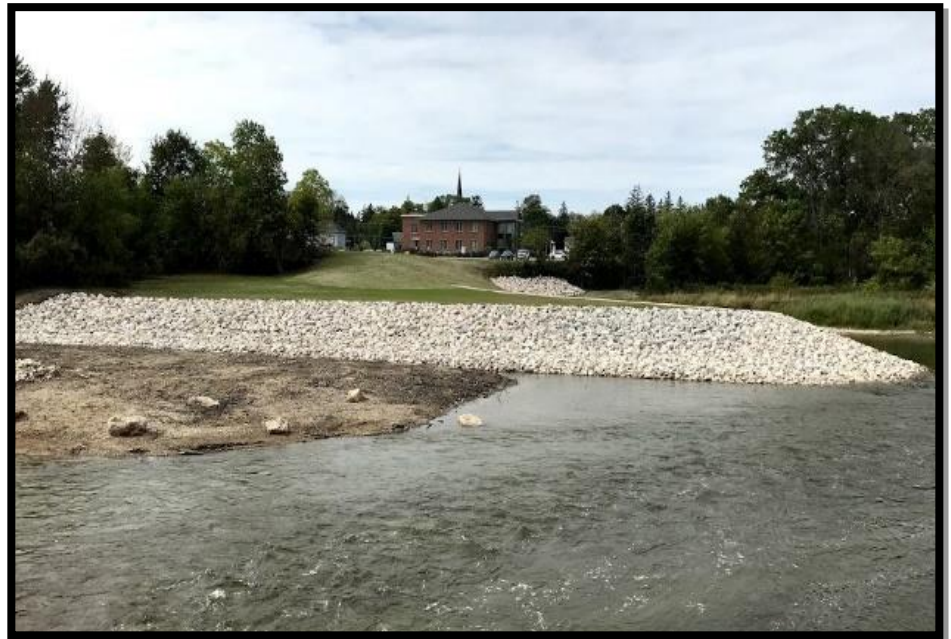
# Truax Dam Removal – Saugeen River in Walkerton (2019)

- Minimal sediment upstream of dam due to high flood flow energies through head pond.
- Access on south side a major challenge. New gravel access road built to avoid driving on flood berm.
- Partial dam removal created new, elevated public space in corner of former head pond.

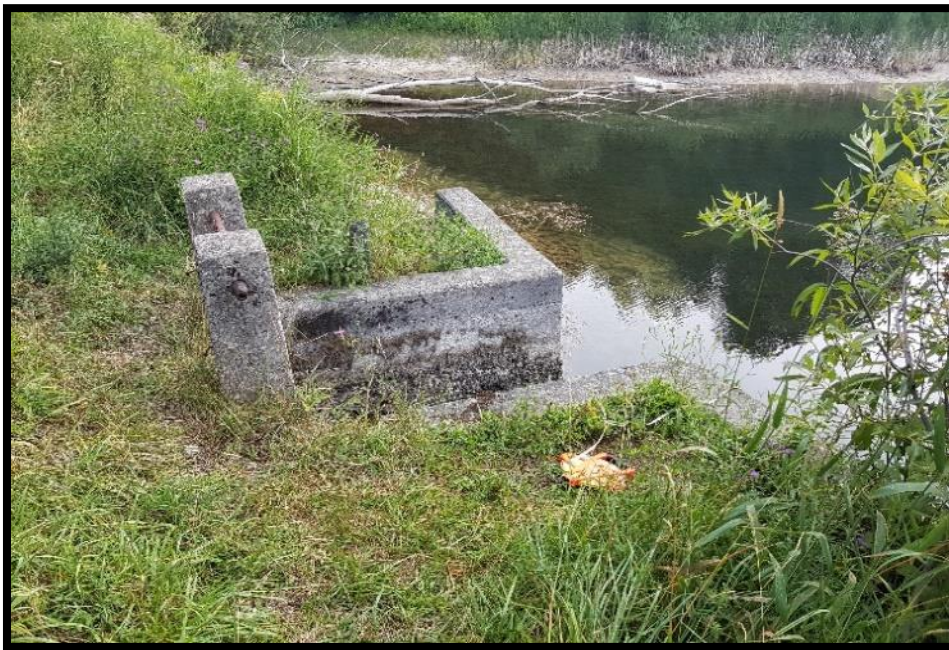
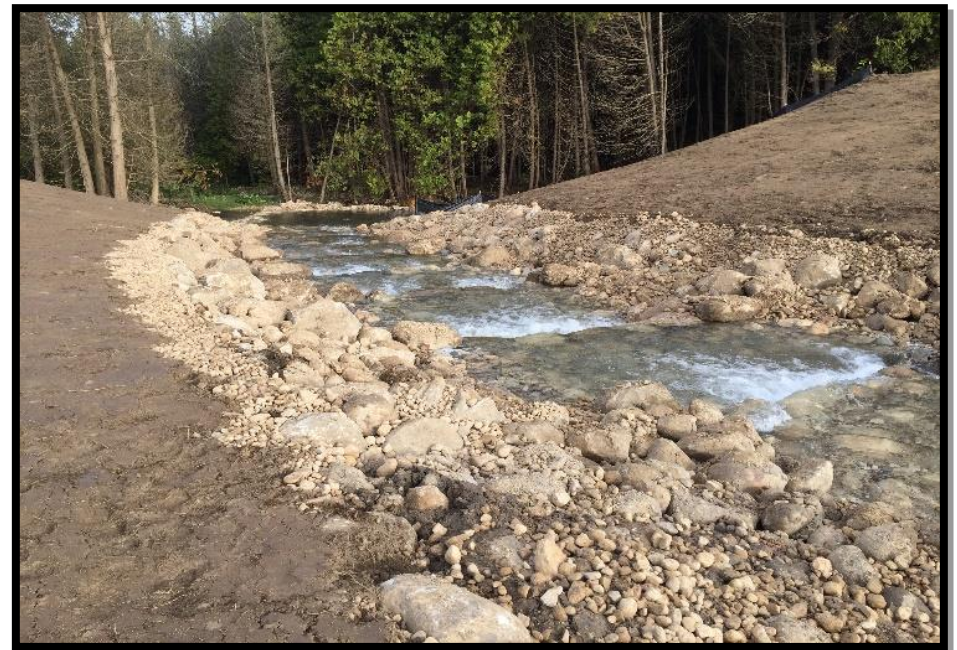
## Town Pond Dam Removal – Armstrong Creek in Markdale (2020)

- Partial dam removal in order to store sediment in residual head pond
- Series of set pools through based of former dam has created a major, scenic waterscape feature
- New nature and interpretative trail has been built on former head pond sediment for entire length of head pond.

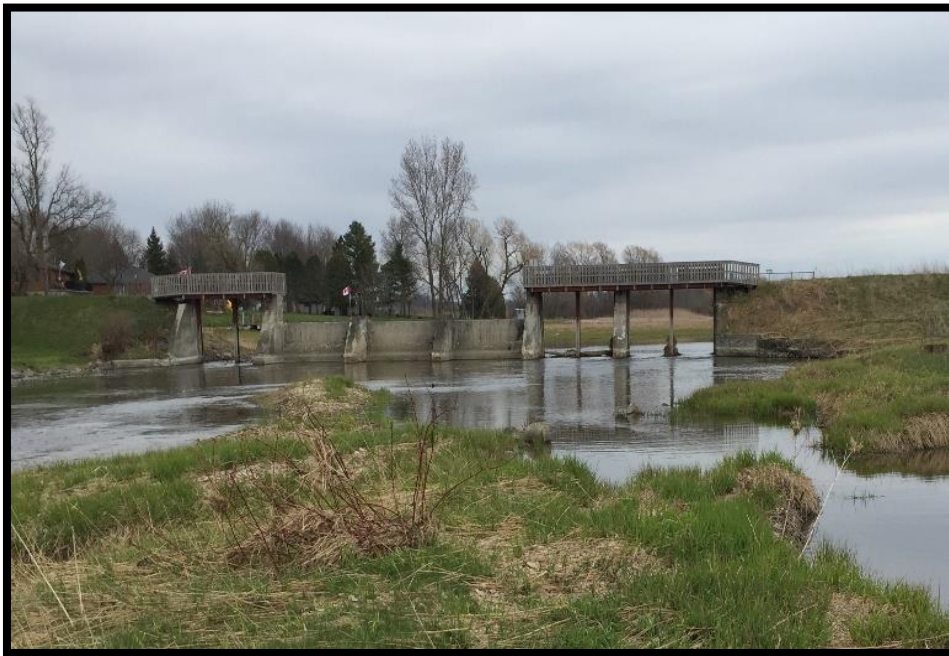
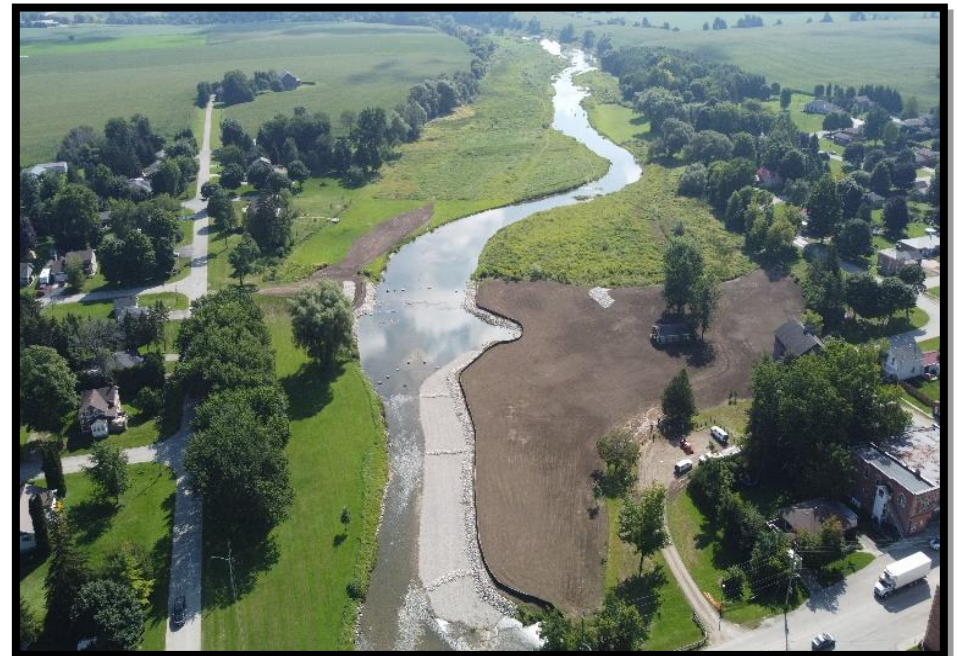
## Gorrie Dam Removal – North Maitland River in Gorrie (2021)

- Earthen berm portion of dam had failed twice previously during June 2017 flood and February 2018 high water event
- Project included new low flow channel design downstream of dam site
- Overall project featured significant landscaping of entire site including site drainage

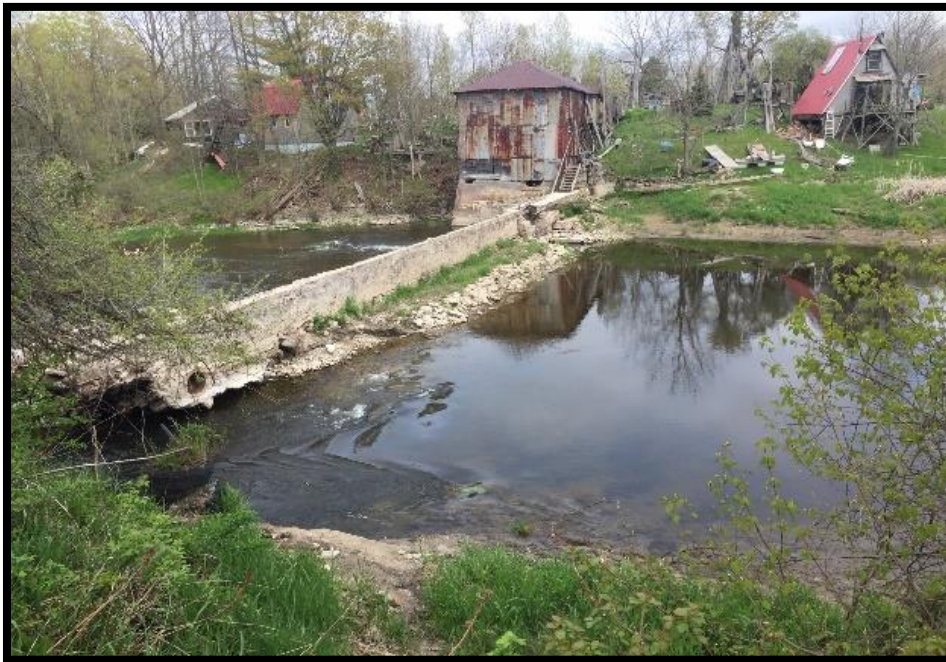
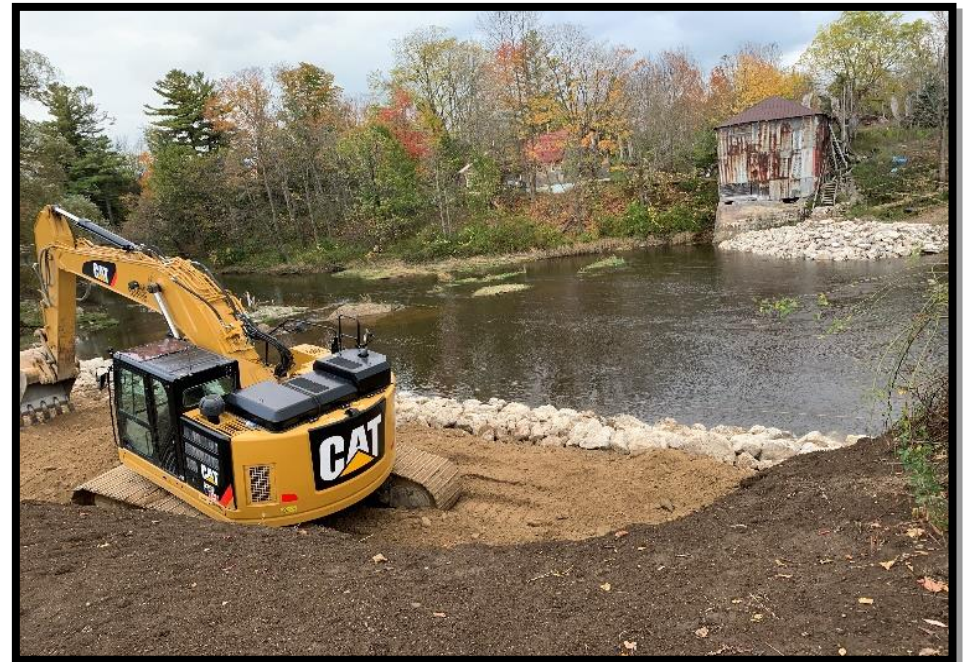
## Park Head Dam Removal – Sauble River in Park Head (2021)

- Dam had failed at west end – the flanking flood flows seriously eroded the adjacent private property and risked destroying a residential home.
- During design and permitting process, owner of dam died. MNRF would not issue LRIA permit to the estate of the deceased. The estate trustee reluctantly agreed to be the LRIA applicant.

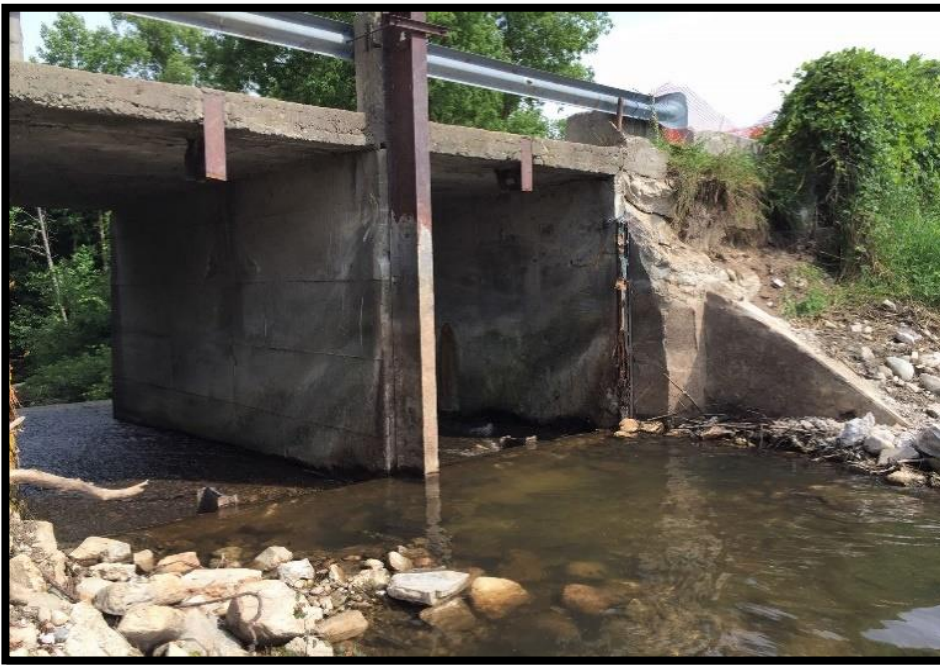
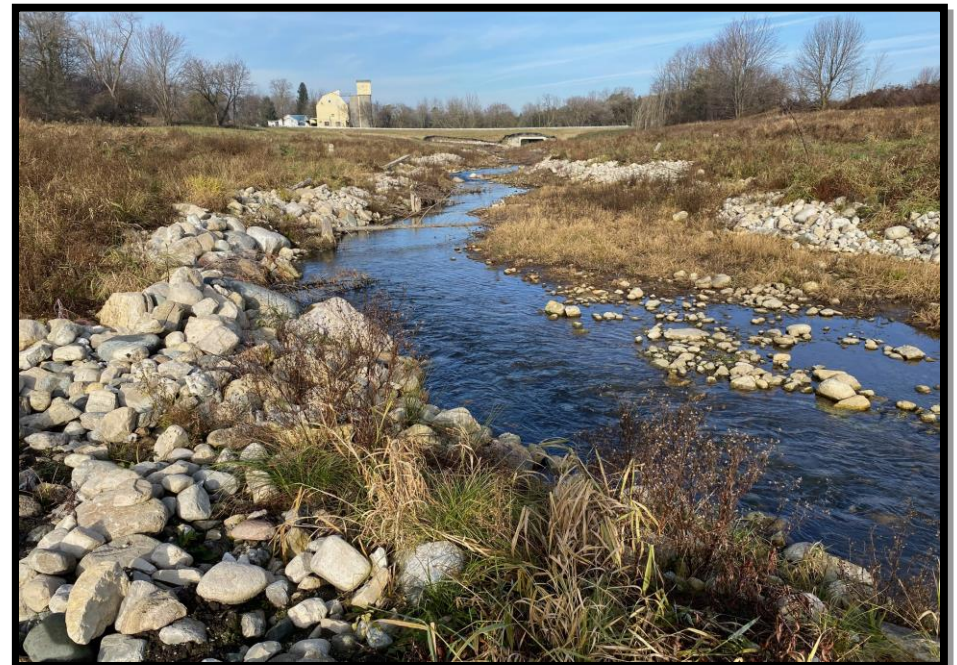
## Adam Street Dam Removal – Otter Creek in Mildmay (2022/2023)

- This dam featured 400 m long head pond that was full of sediment to 8' deep.
- While sediment plan established, effective sediment management proved to be very difficult.
- Bypass pipe installed to allow sediment work to be done “in the dry” but bypass pipe installs are very complicated.

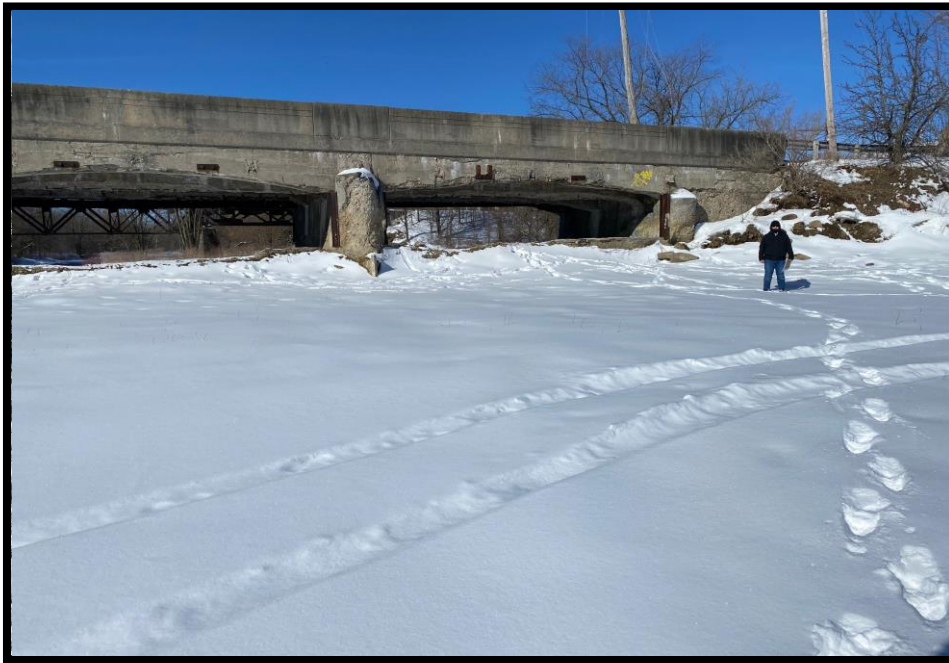
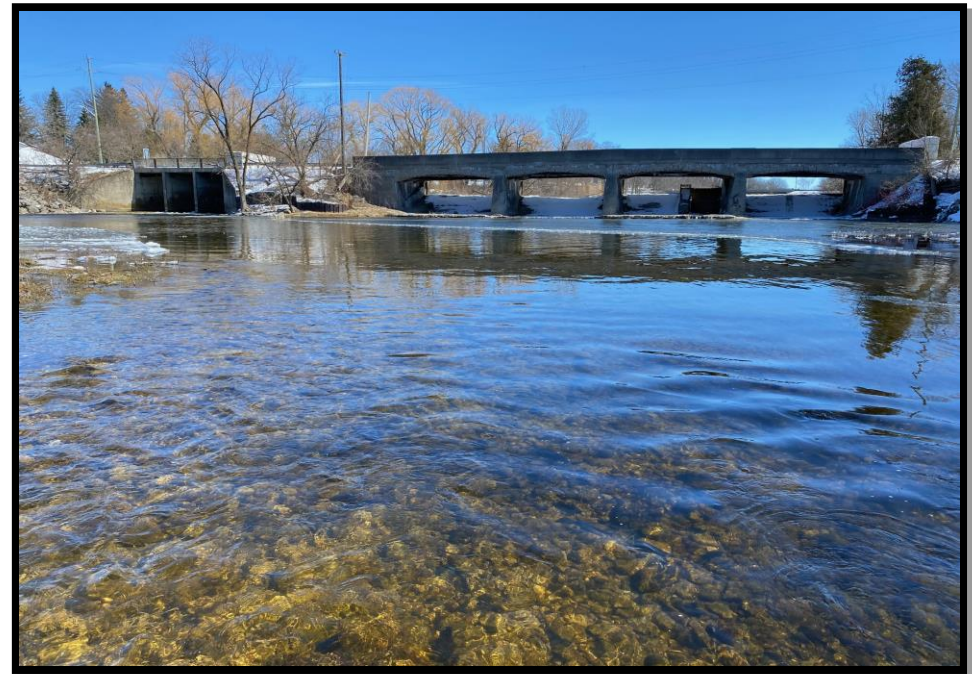
## Howson Dam Removal (proposed) – North Maitland River in Wingham (in progress)

- Project still in permitting phase. Two permit applications took almost 1.5 years
- Permitting on this project has now expanded to 5 federal and provincial ministries/departments
- Conversely, no significant sediment upstream of dam and very good dam access both sides.

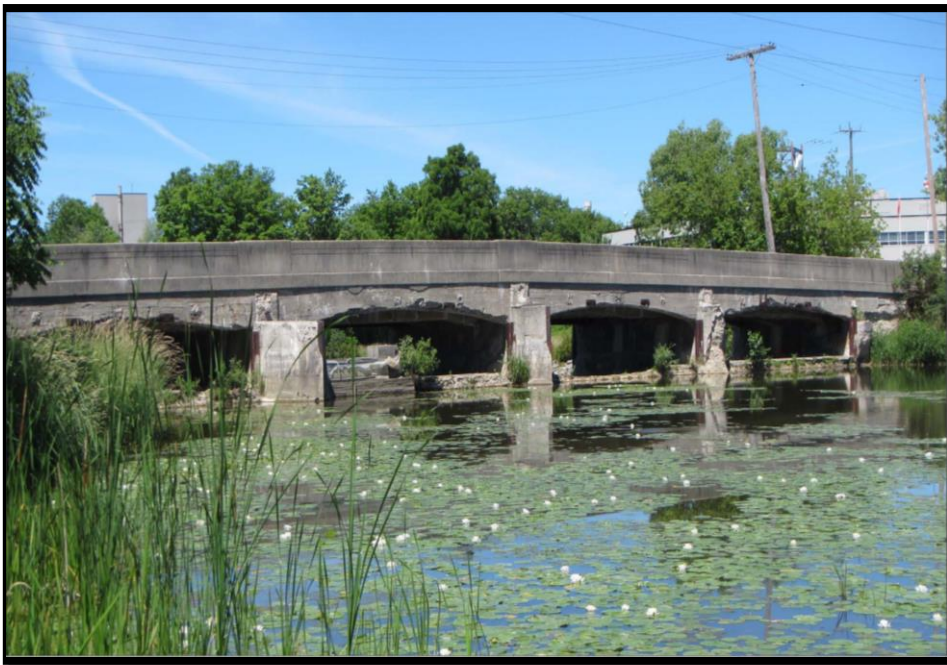
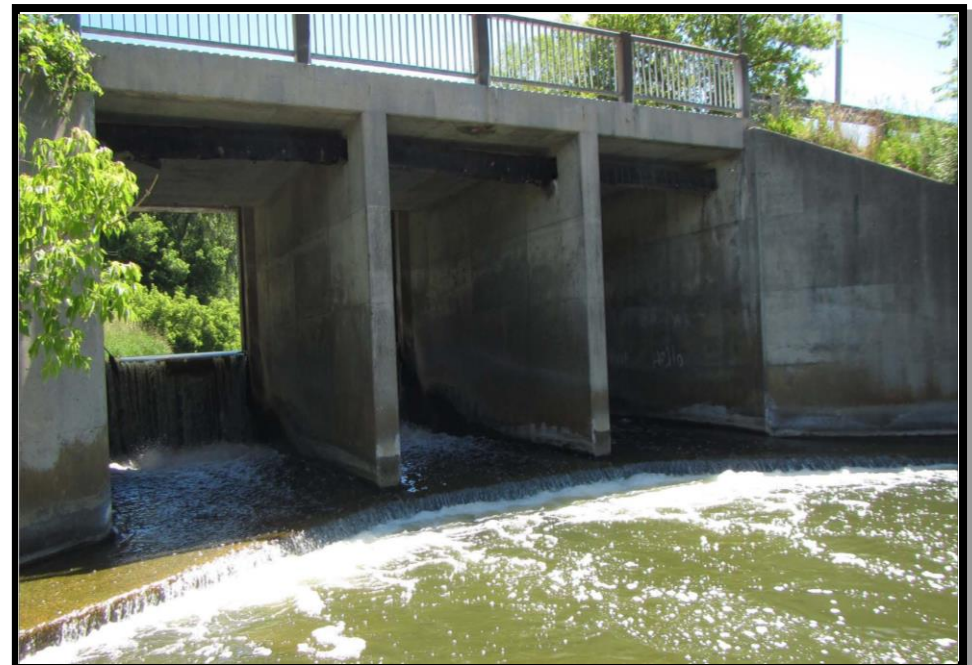
## Howson Dam Removal (proposed) – North Maitland River in Wingham (in progress).....continued

- South part of dam (left above) has been structurally condemned and could fail anytime.
- Structural reports - completed 40 years ago – concluded there was no compressive concrete strength in south part of dam. South part of dam is over 100 years old.
- North part of dam added more recently but is still 57 years old.

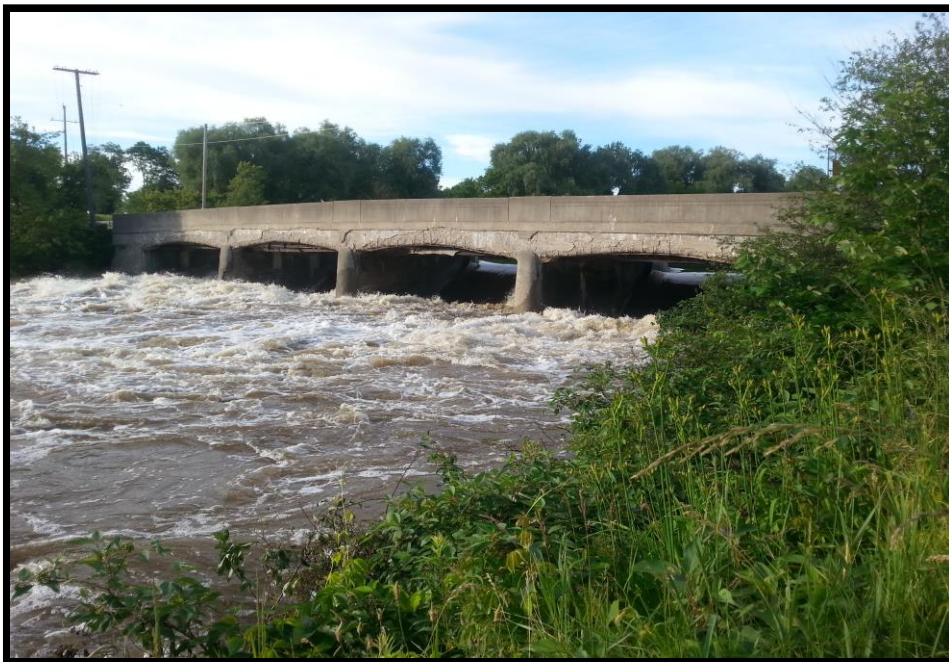
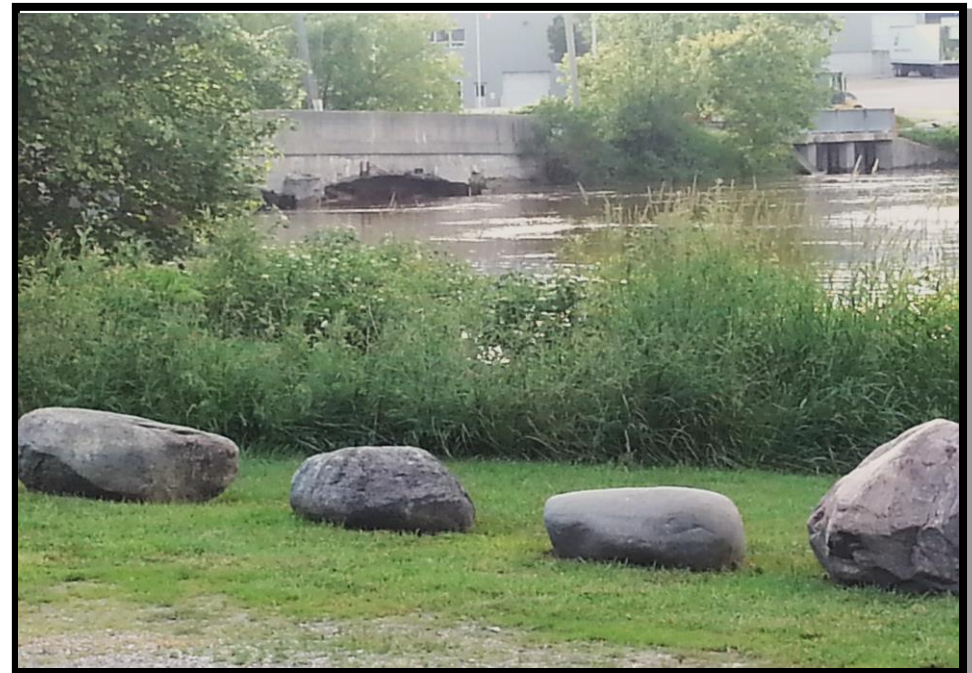
## Howson Dam Removal (proposed) – North Maitland River in Wingham (in progress).....continued

- Pictures of June 2017 flood caused by non forecasted “training” thunderstorms. Up to 150 mm in short period.
- Env Can flow gauge upstream estimated flow as 410 cms.
- Spillway capacity of dam close to exceedance during event. Large trees or debris did not partially block the spillways but could have.
