# Petun Dam Removal Project

Fred Dobbs, Manager Stewardship Services  
Laura Wensink, River Restoration Technician  
29 November, 2023

# Petun Dam Removal and Restoration of Black Ash Creek

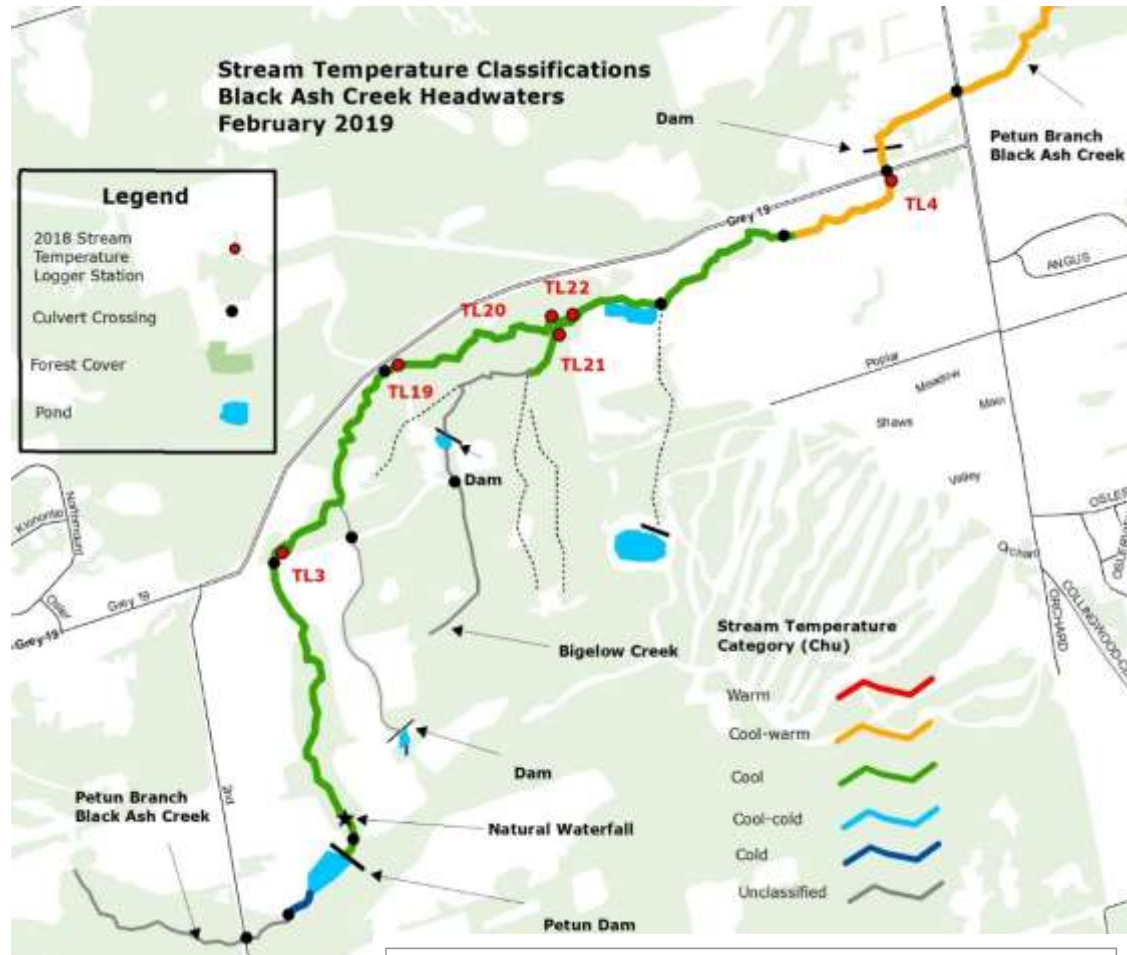
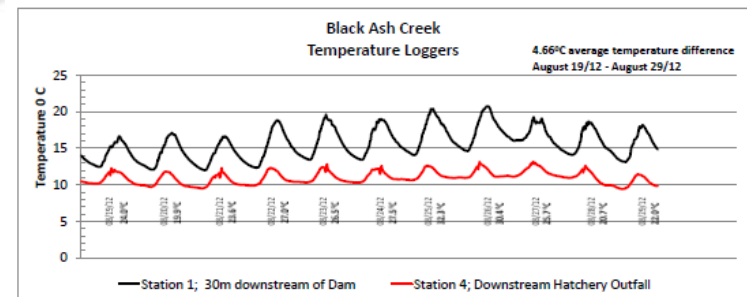
Black Ash Creek was **COLD** upstream of the dam.

The water warmed significantly in the head pond and exited **7C** warmer, changing the stream classification to **COOL**.

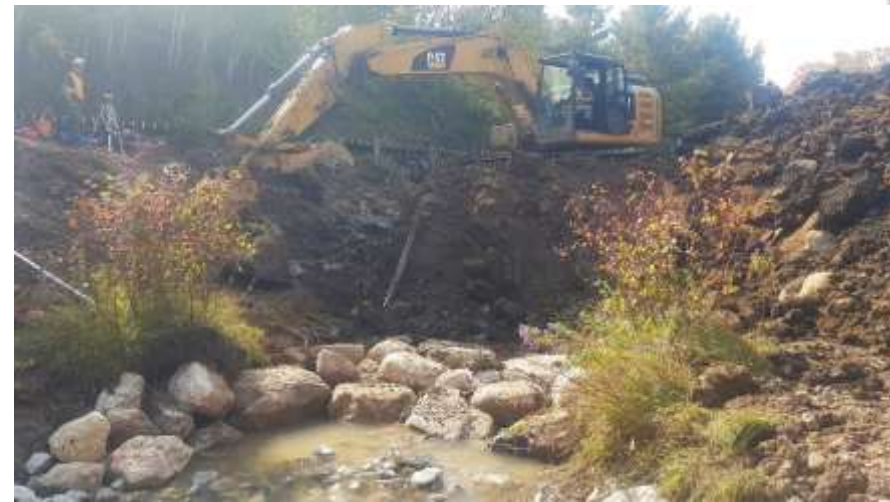
- » The steep valley required a step-pool section through the berm.
- » Uncovering natural channel beneath pond

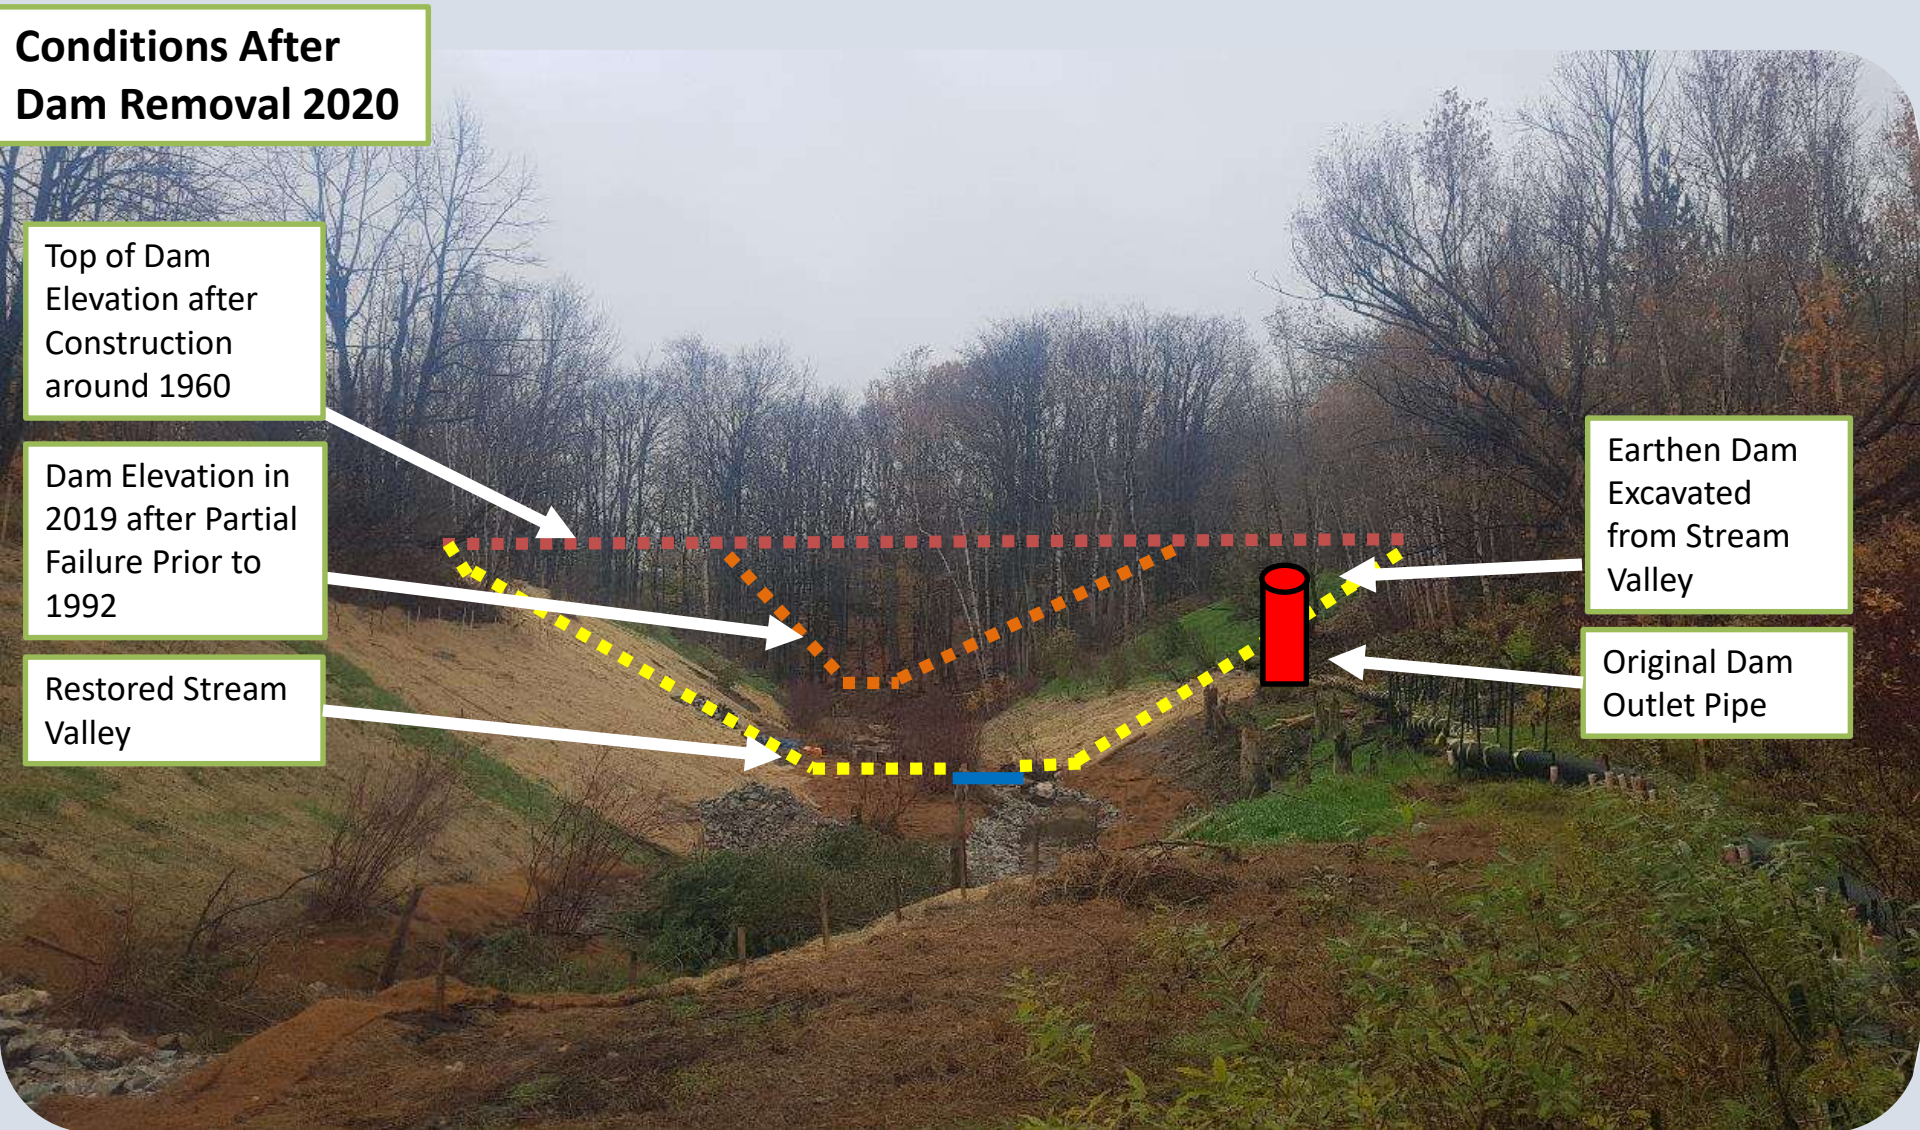
Top of Dam Elevation after Construction around 1960

Dam Elevation in 2019 after Partial Failure Prior to 1992

Restored Stream Valley

Earthen Dam Excavated from Stream Valley

Original Dam Outlet Pipe

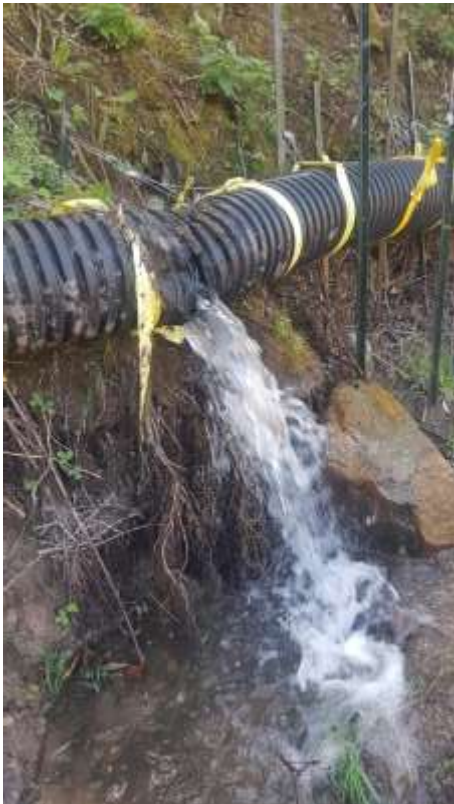
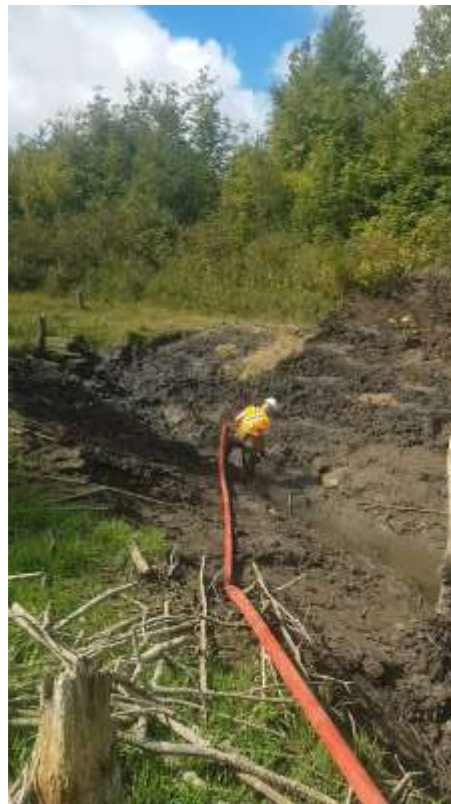
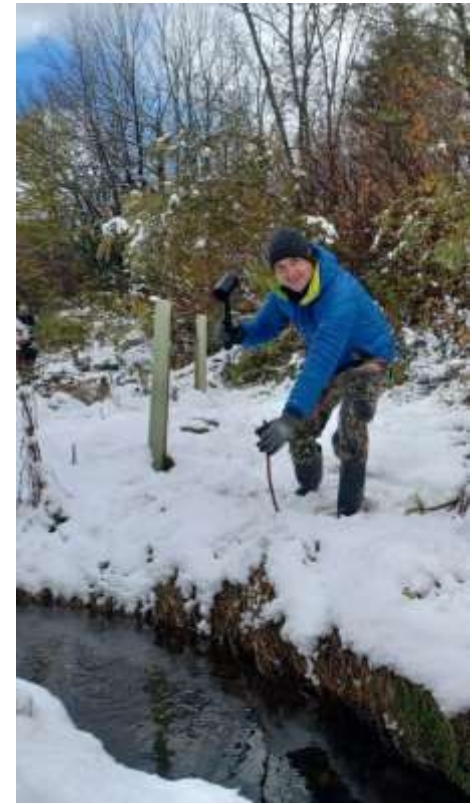
- » Bypass pipe made from plastic is delicate
- » Difficult to excavate original channel without disturbing channel bed
- » Wet weather prevented triaxle trucks from accessing site
